**EROSION CONTROL DEMONSTRATION
PROJECTS STUDY
(P. L. 93-251 SECTION 32)**

**MRD HYDRAULIC LABORATORY SERIES
REPORT NO. 9**

**LABORATORY INVESTIGATION OF
EROSION CONTROL USING HARD POINTS**

**U. S. ARMY ENGINEER DISTRICT, OMAHA
MISSOURI RIVER DIVISION, OMAHA
NOVEMBER 1977**

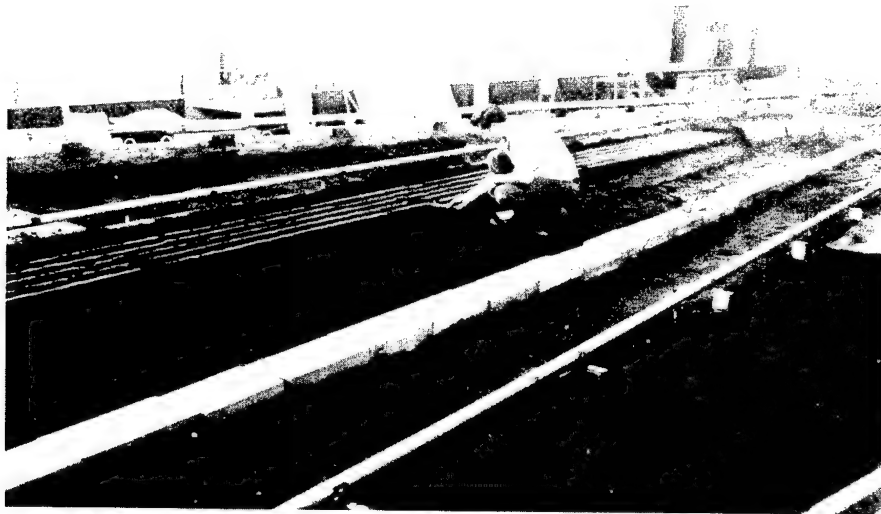
Picture 5: Excavation of the root trench into the right bank.

After the channel bank was reformed, the selected hard point spacing interval was measured off and prepared for rock placement. Hard point structures require two types of rock placement, the root and the nose. A rectangular root trench was cut into the bank lines with the dimensions dictated by the preselected quantity of rock to be used. The trench was cut about a foot back and 0.2 foot deep and 0.4 foot wide. The trench was then filled with the specified quantity of rock per foot. The rock nose was formed by dumping the rock directly onto the channel bank and tied into the rock root. The process is shown in pictures 5 and 6. The gradation for the rock used in modeling the hard point structure was scaled down from the rock gradation currently being specified for hard points on the Missouri River. The gradation comparison is shown on plate 2.

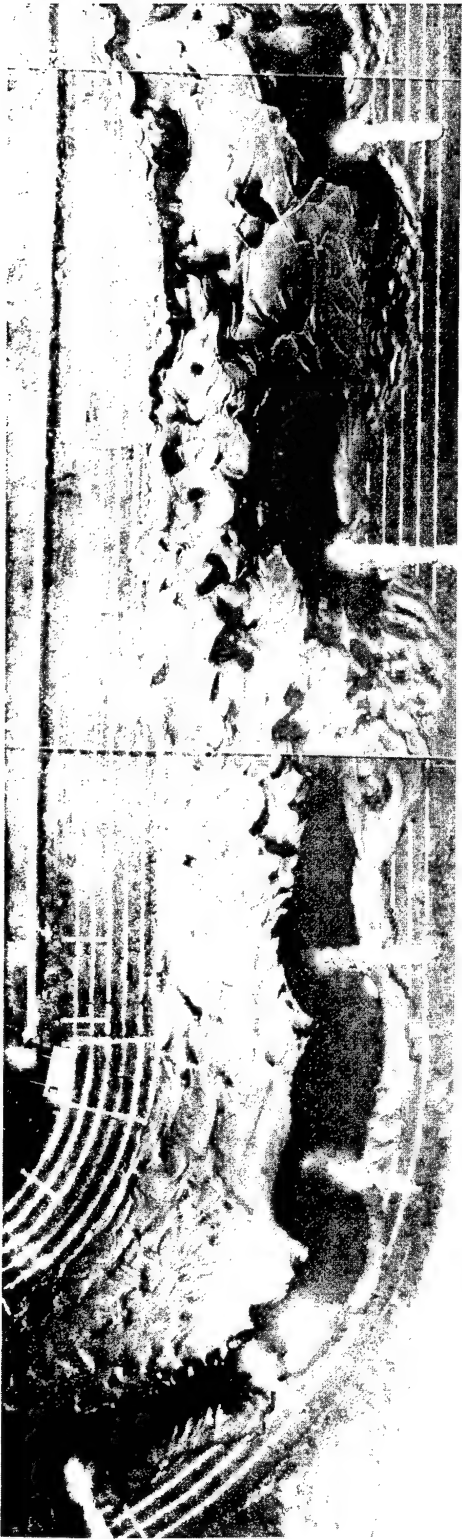
Picture 7: Failure of the hard points in the curve due to insufficient quantity of rock in the nose. The rock migrates to the bottom of the channel.

Initially, the tests involved the placing of hard point structures in the upstream curve and the straight reach at 5 and 7.5-foot intervals. For the initial tests, 4 lbs of rock were used in the nose and 3.5 lb/ft of rock were used in the root of each structure. This quantity of rock for the indicated discharge resulted in failure of the structures in both regions. The volume of rock was apparently insufficient to protect against the resulting scour which caused it to migrate to the bottom of the channel. Typical structure failures are shown in pictures 7 and 8.
